1. PLUS Radios: FGR2-P and FGR2-PE

1.2. Version 3.13

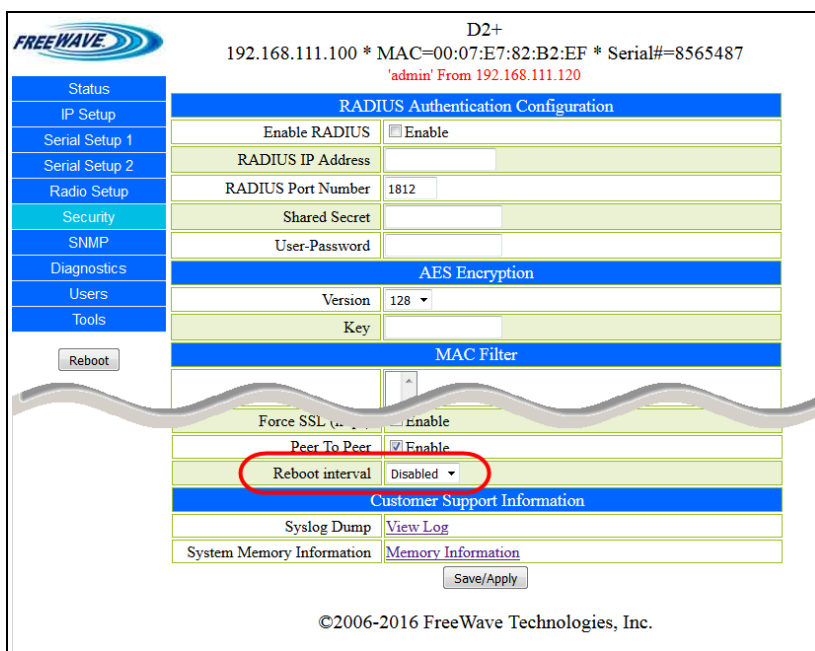
Figure 1: Security window - Reboot Interval list box

In the **Security** window, in the **Miscellaneous** area, a new **Reboot Interval** list box option has been added.

- By default, the **Reboot Interval** is **Disabled**.
 - If **Disabled** is selected, the PLUS Radio will operate without automatically rebooting.
 - When an interval (e.g., **1 Hour**, **1 Day**, **30 Days**) is selected, the scheduler automatically reboots the PLUS Radio when the reboot interval expires.
