1. PLUS Radios: HTP-900RE and HTP-900SEO

These sections describe the updates and known limitations in each software version for the HTP-900RE and HTP-900SEO PLUS Radios. The most recent version is listed first.

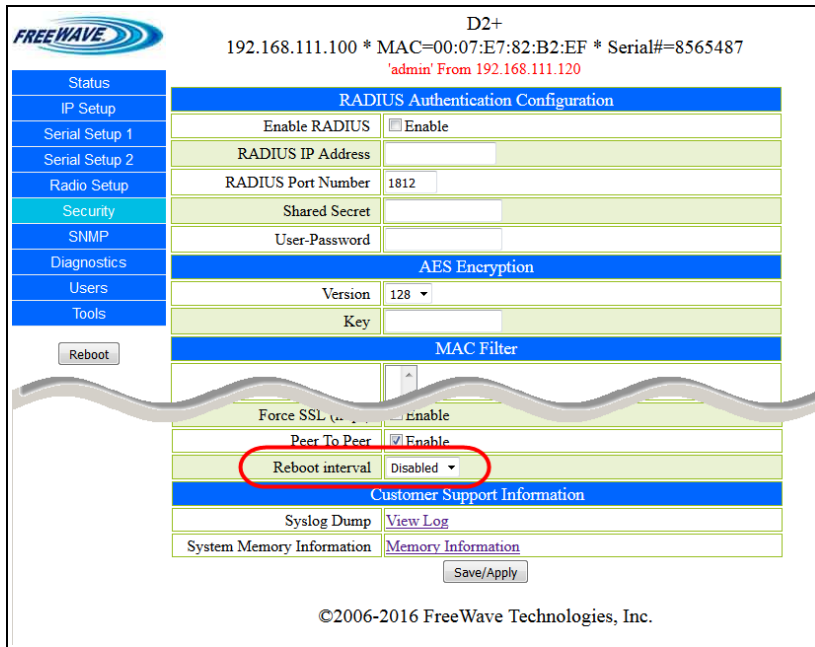
In the **Security** window, in the **Miscellaneous** area, a new **Reboot Interval** list box option has been added.

- By default, the **Reboot Interval** is **Disabled**.
 - If **Disabled** is selected, the PLUS Radio will operate without automatically rebooting.
 - When an interval (e.g., **1 Hour**, **1 Day**, **30 Days**) is selected, the scheduler automatically reboots the PLUS Radio when the reboot interval expires.

Figure 1: Security window - Reboot Interval list box
