## 1. PLUS Radios: HT-P and HT-PE

These sections describe the updates and known limitations in each software version for the HT-P and HT-PE PLUS Radios. The most recent version is listed first.

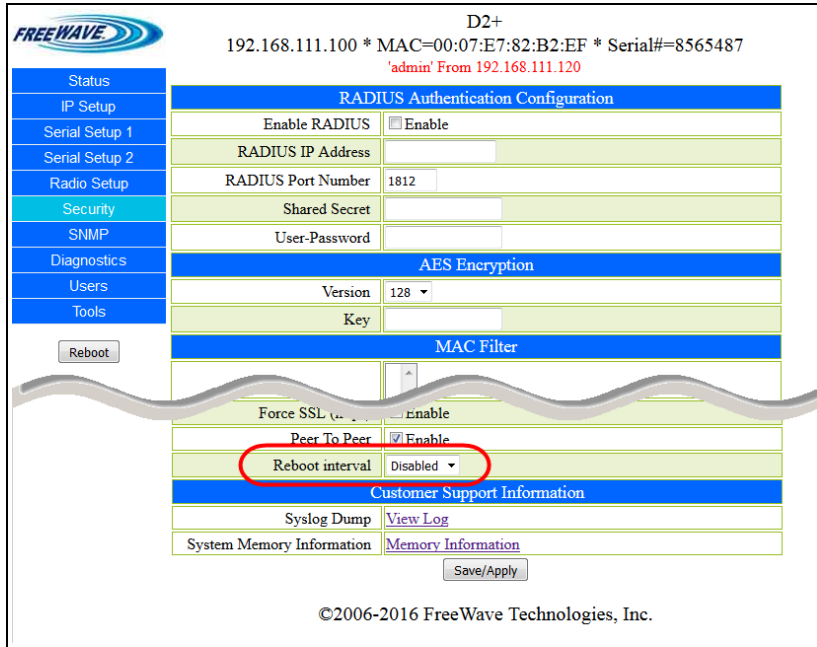
Figure 1: Security window - Reboot Interval list box

In the **Security** window, in the **Miscellaneous** area, a new **Reboot Interval** list box option has been added.

- By default, the **Reboot Interval** is **Disabled**.
  - If **Disabled** is selected, the PLUS Radio will operate without automatically rebooting.
  - When an interval (e.g., **1 Hour**, **1 Day**, **30 Days**) is selected, the scheduler automatically reboots the PLUS Radio when the reboot interval expires.
